**HYDROLOGY STUDY OF  
SALT SLOUGH, MERCED COUNTY**

**California Regional Water Quality Control Board  
Central Valley Region  
3443 Routier Road  
Sacramento, California 95827-3098**

**February 1989**

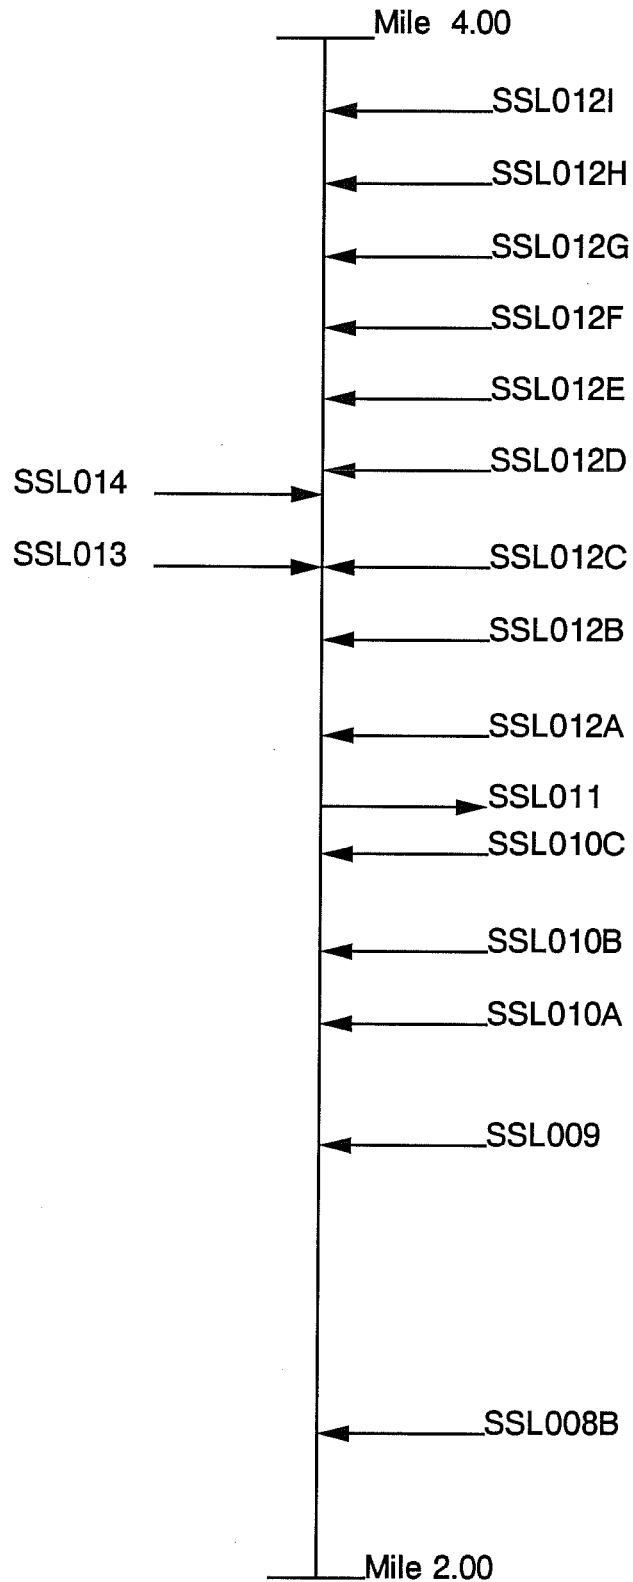
Mile 2.00 - Mile 4.00

# SALT SLOUGH

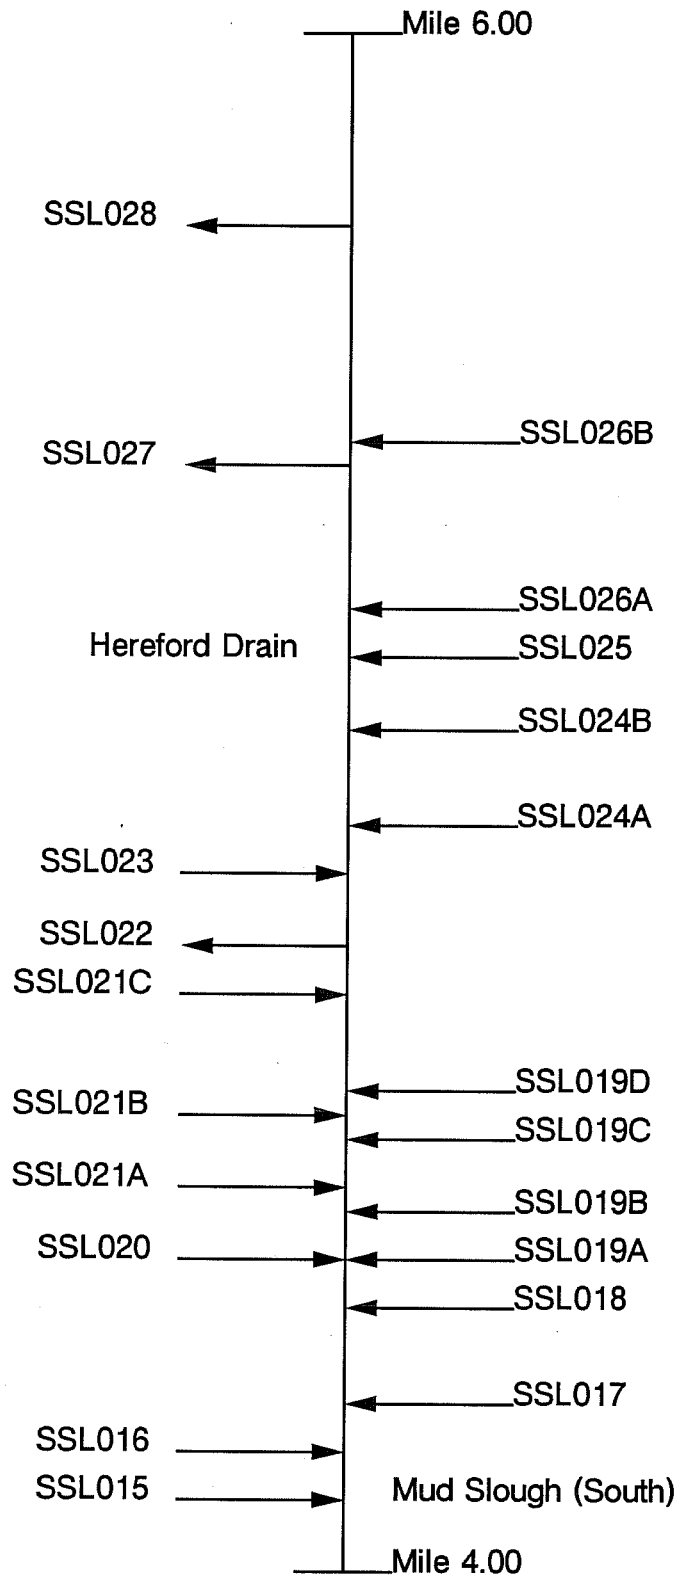
Mile 4.00 - Mile 6.00

# SALT SLOUGH

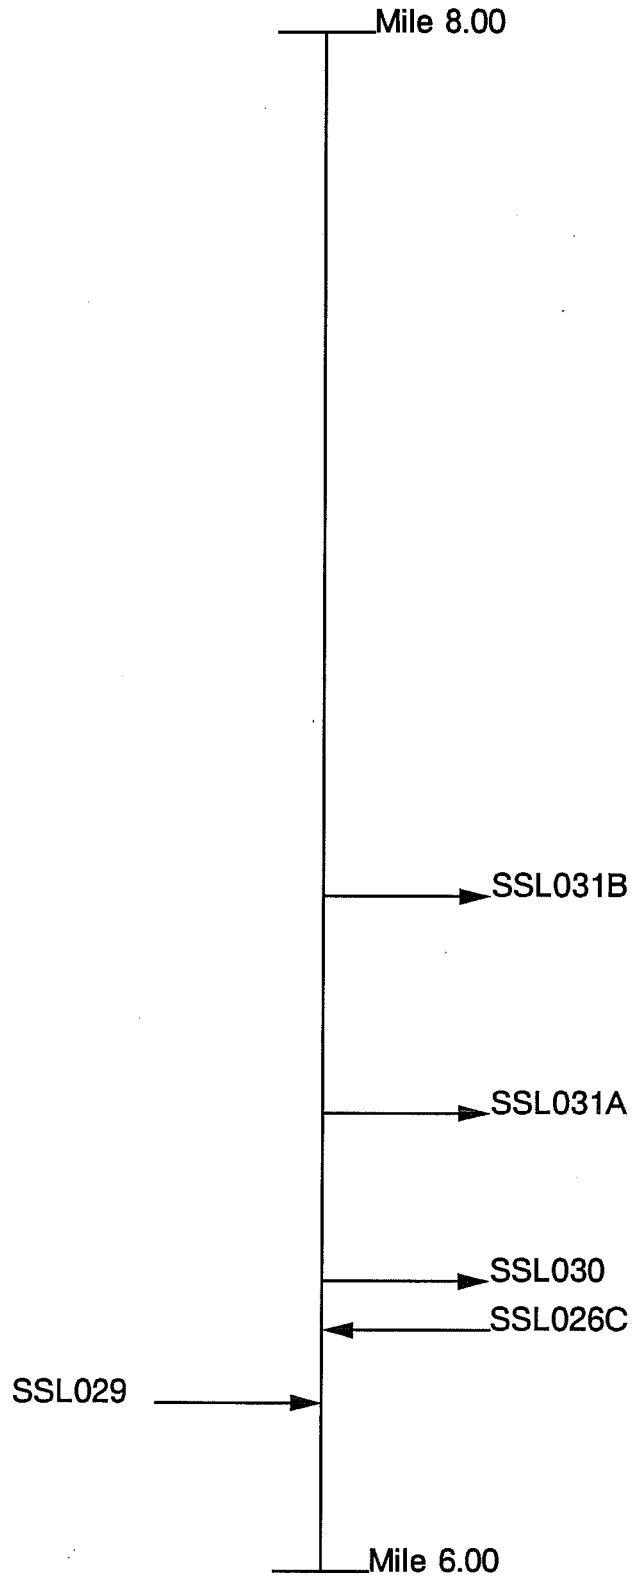
Mile 6.00 - Mile 8.00

# SALT SLOUGH

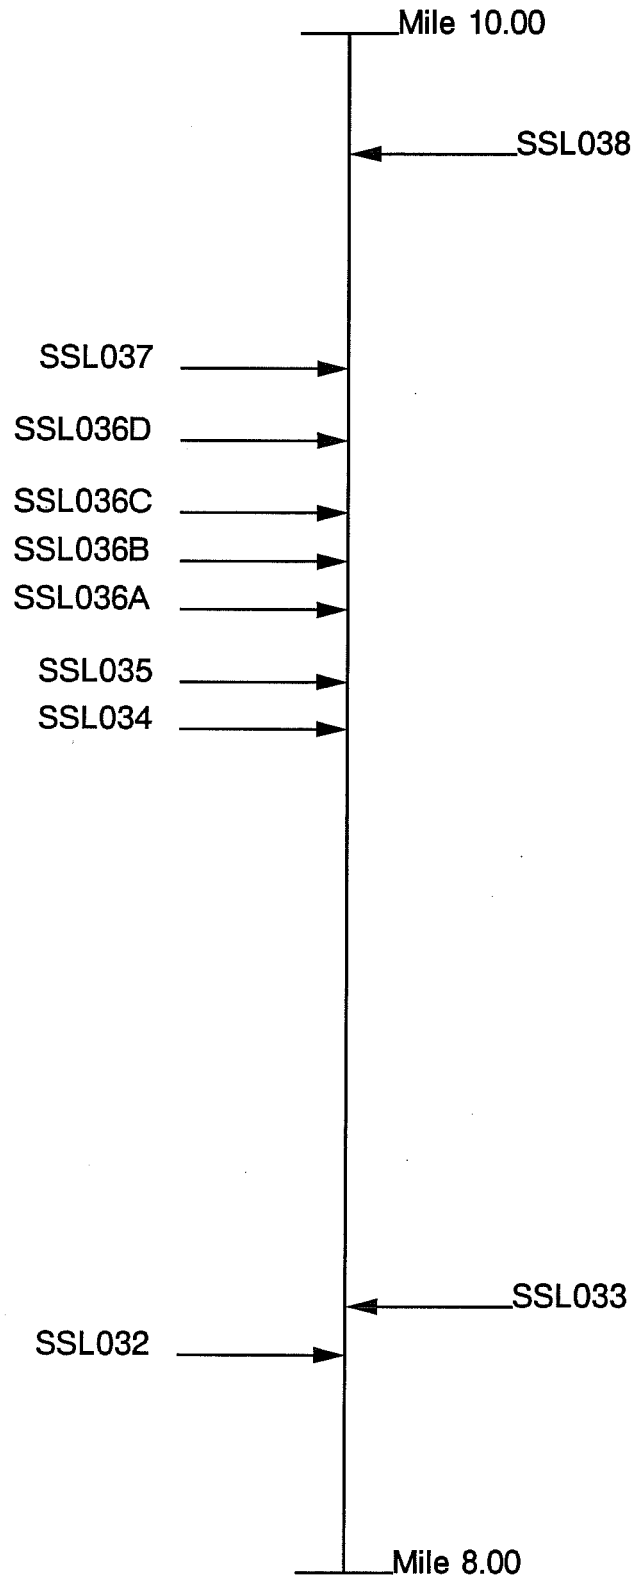
Mile 8.00 - Mile 10.00

# SALT SLOUGH

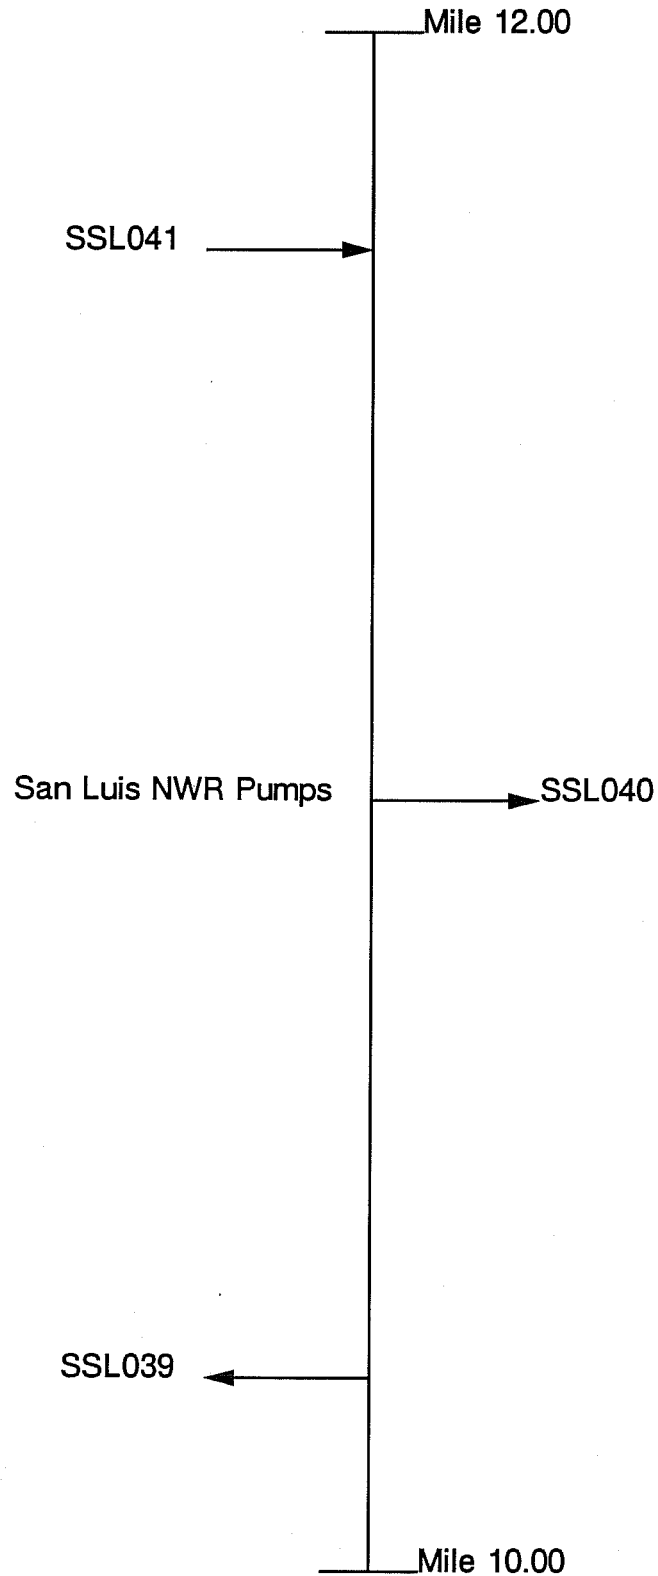
Mile 10.00 - Mile 12.00

# SALT SLOUGH

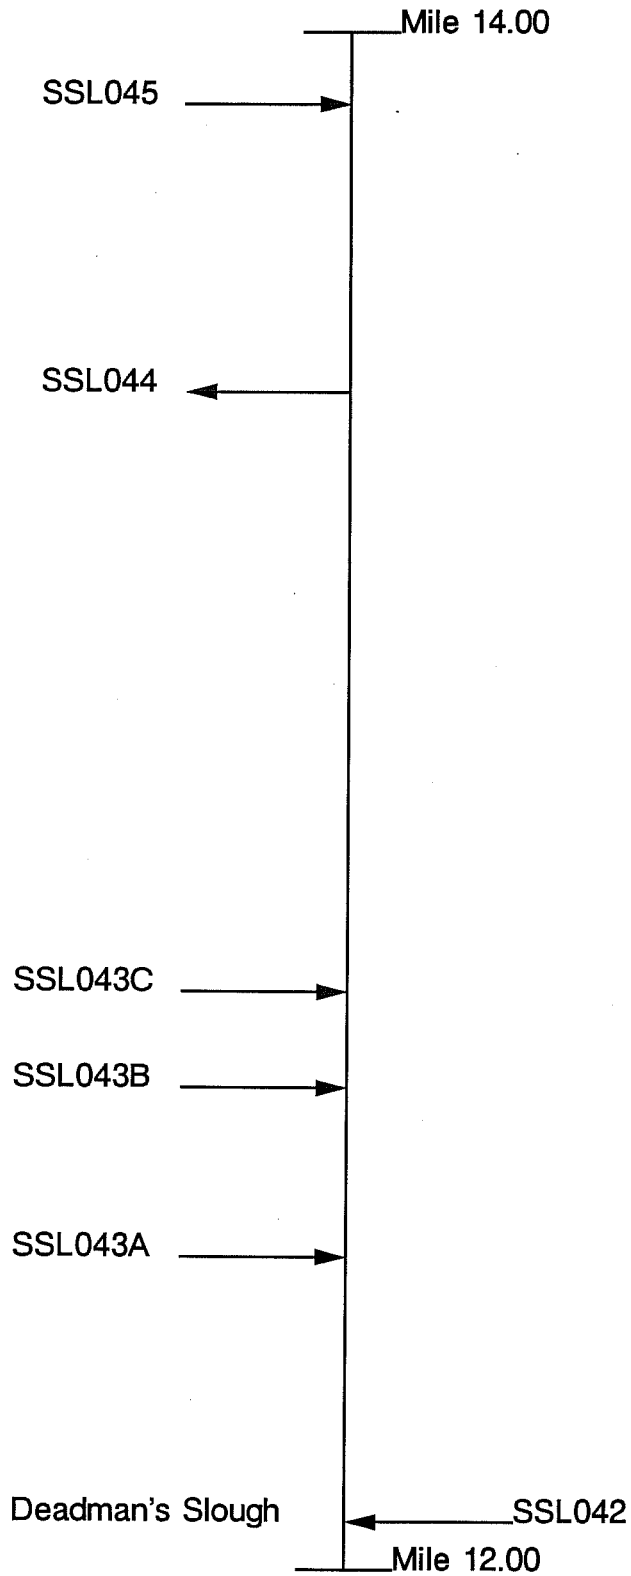
Mile 12.00 - Mile 14.00

# SALT SLOUGH

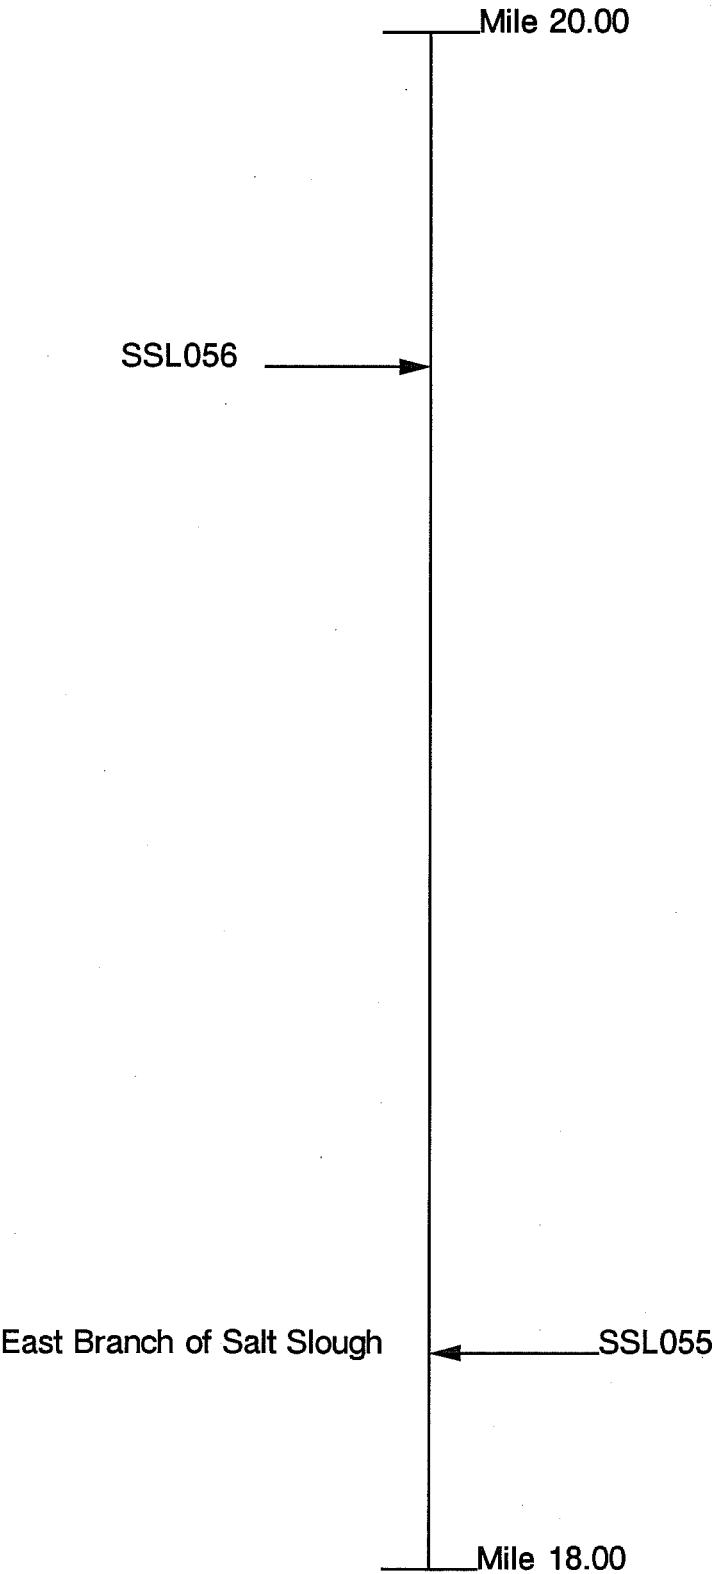
Mile 18.00 - Mile 20.00

SALT SLOUGH

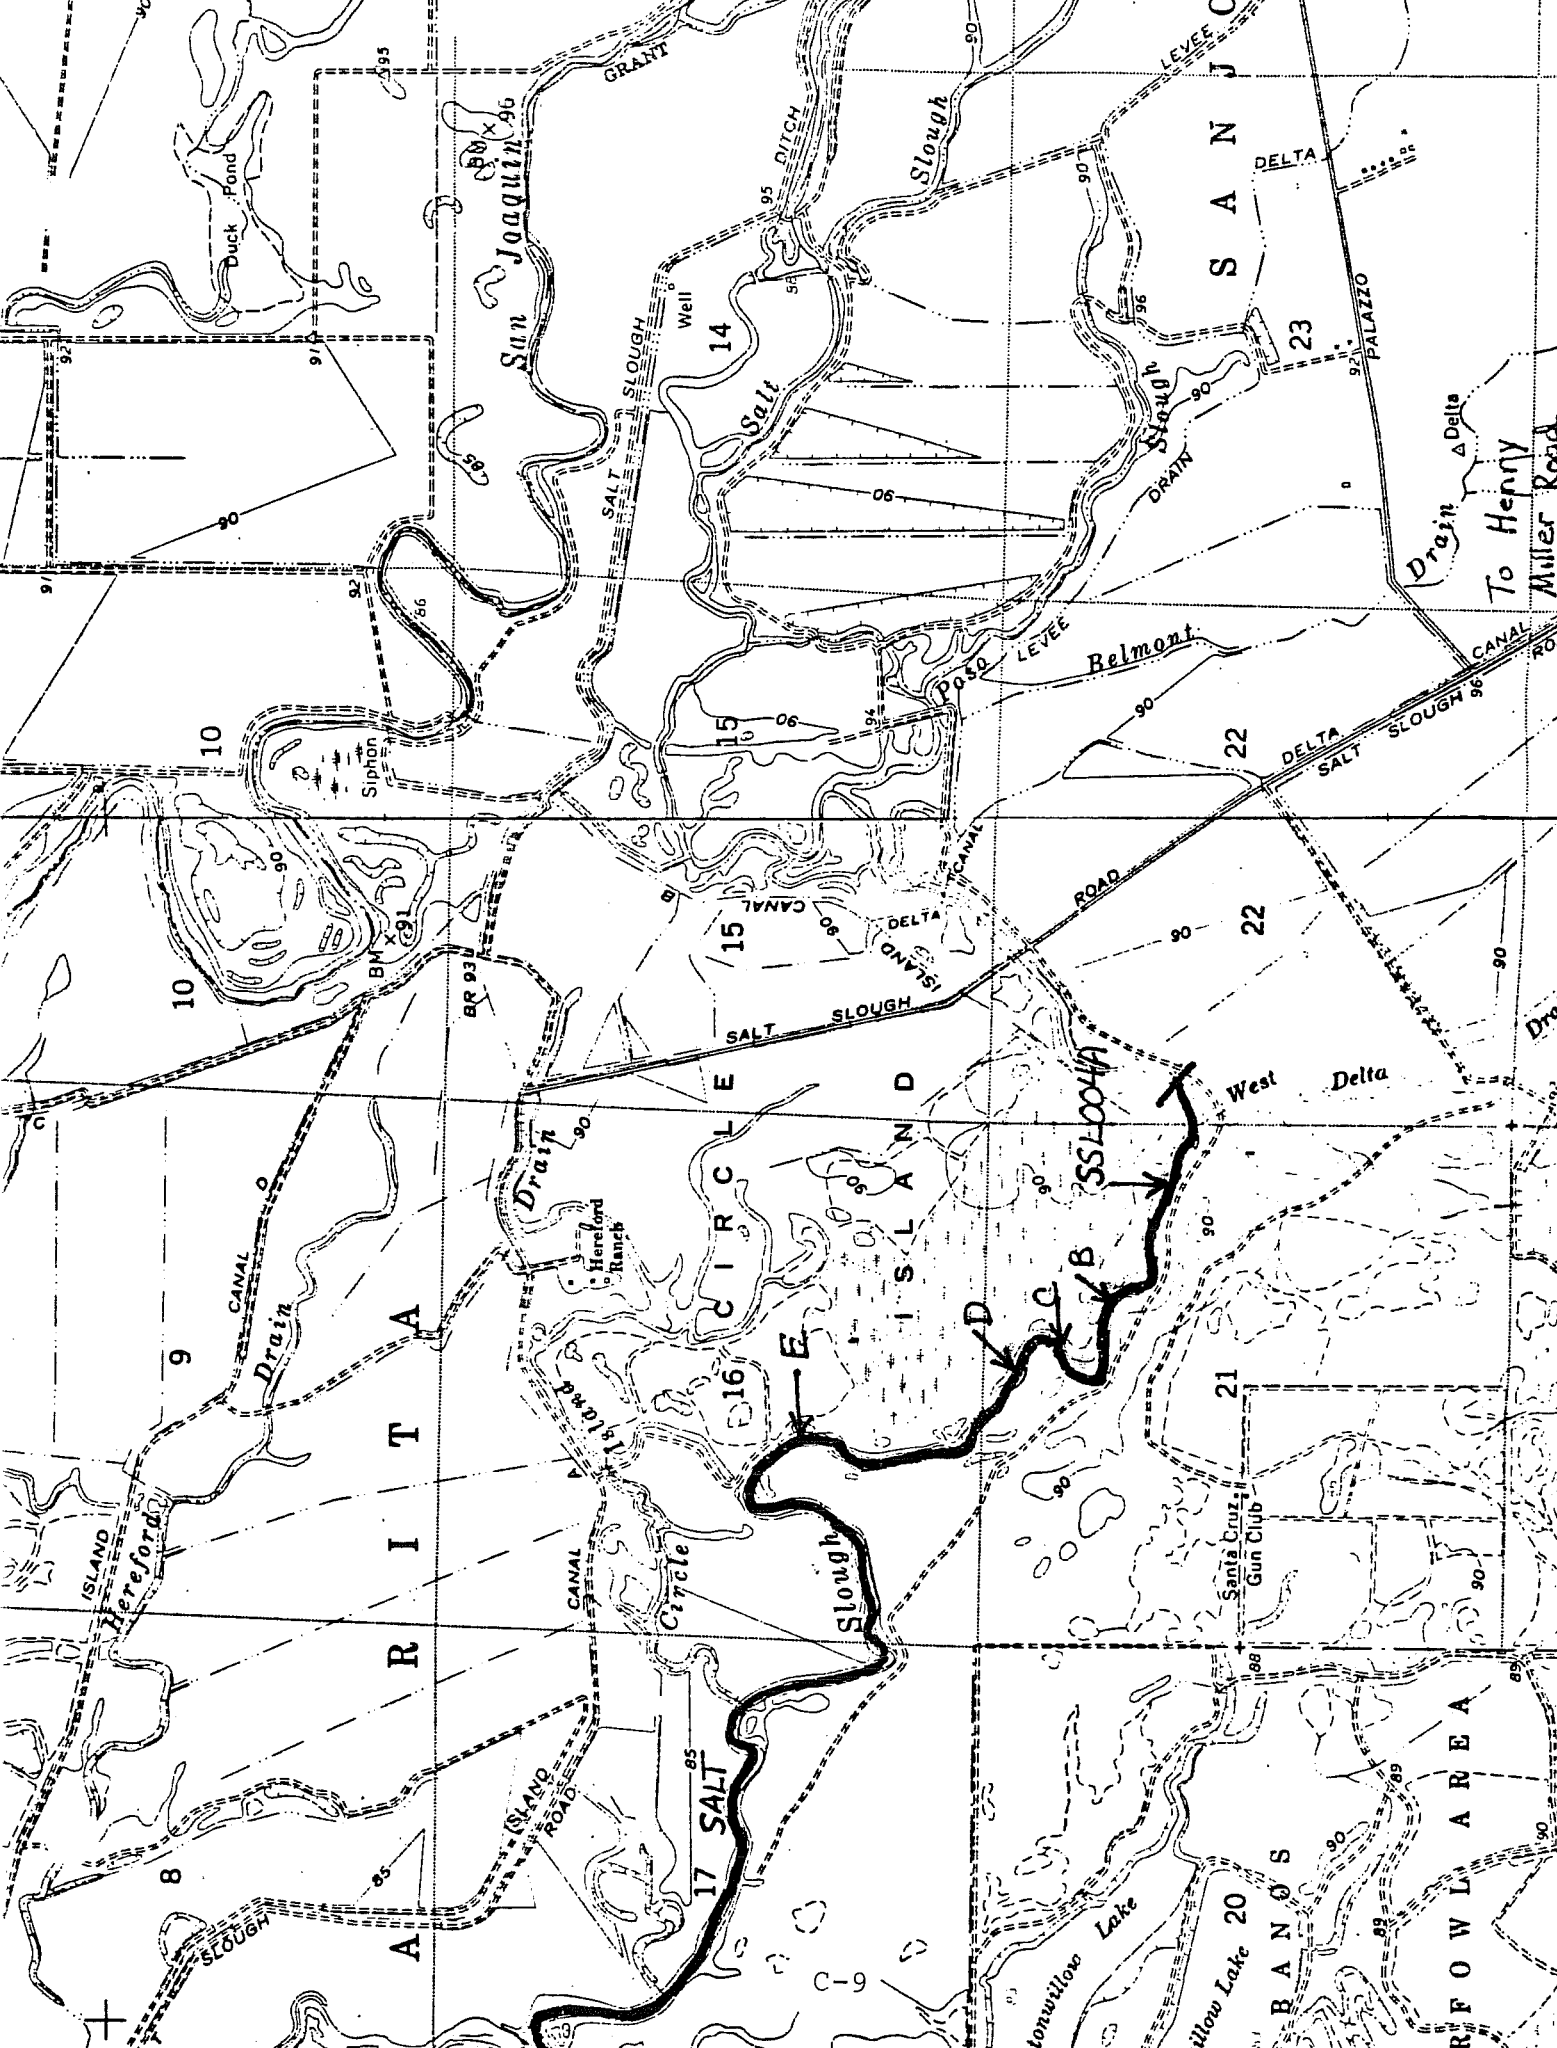
SITE ID #SSL004A-E

**Type and source of water being discharged (description):** Each drain is a field drain draining surface water from an area just north of Salt Slough.

<u>Site #</u>	<u>Slough Mileage</u>	<u>Site Description</u>
SSL004A	0.16N	Corrugated pipe entering Slough.
SSL004B	0.37N	Pipe entering Slough, 0.2 miles west of SSL004A.
SSL004C	0.43E	Corrugated pipe undercrossing the levee road 0.3 miles northwest of SSL004A.
SSL004D	0.51E	Corrugated pipe undercrossing the levee road 0.35 miles northwest of SSL004A.
SSL004E	1.16E	Corrugated pipe undercrossing the levee road 1.0 miles northwest of SSL004A.

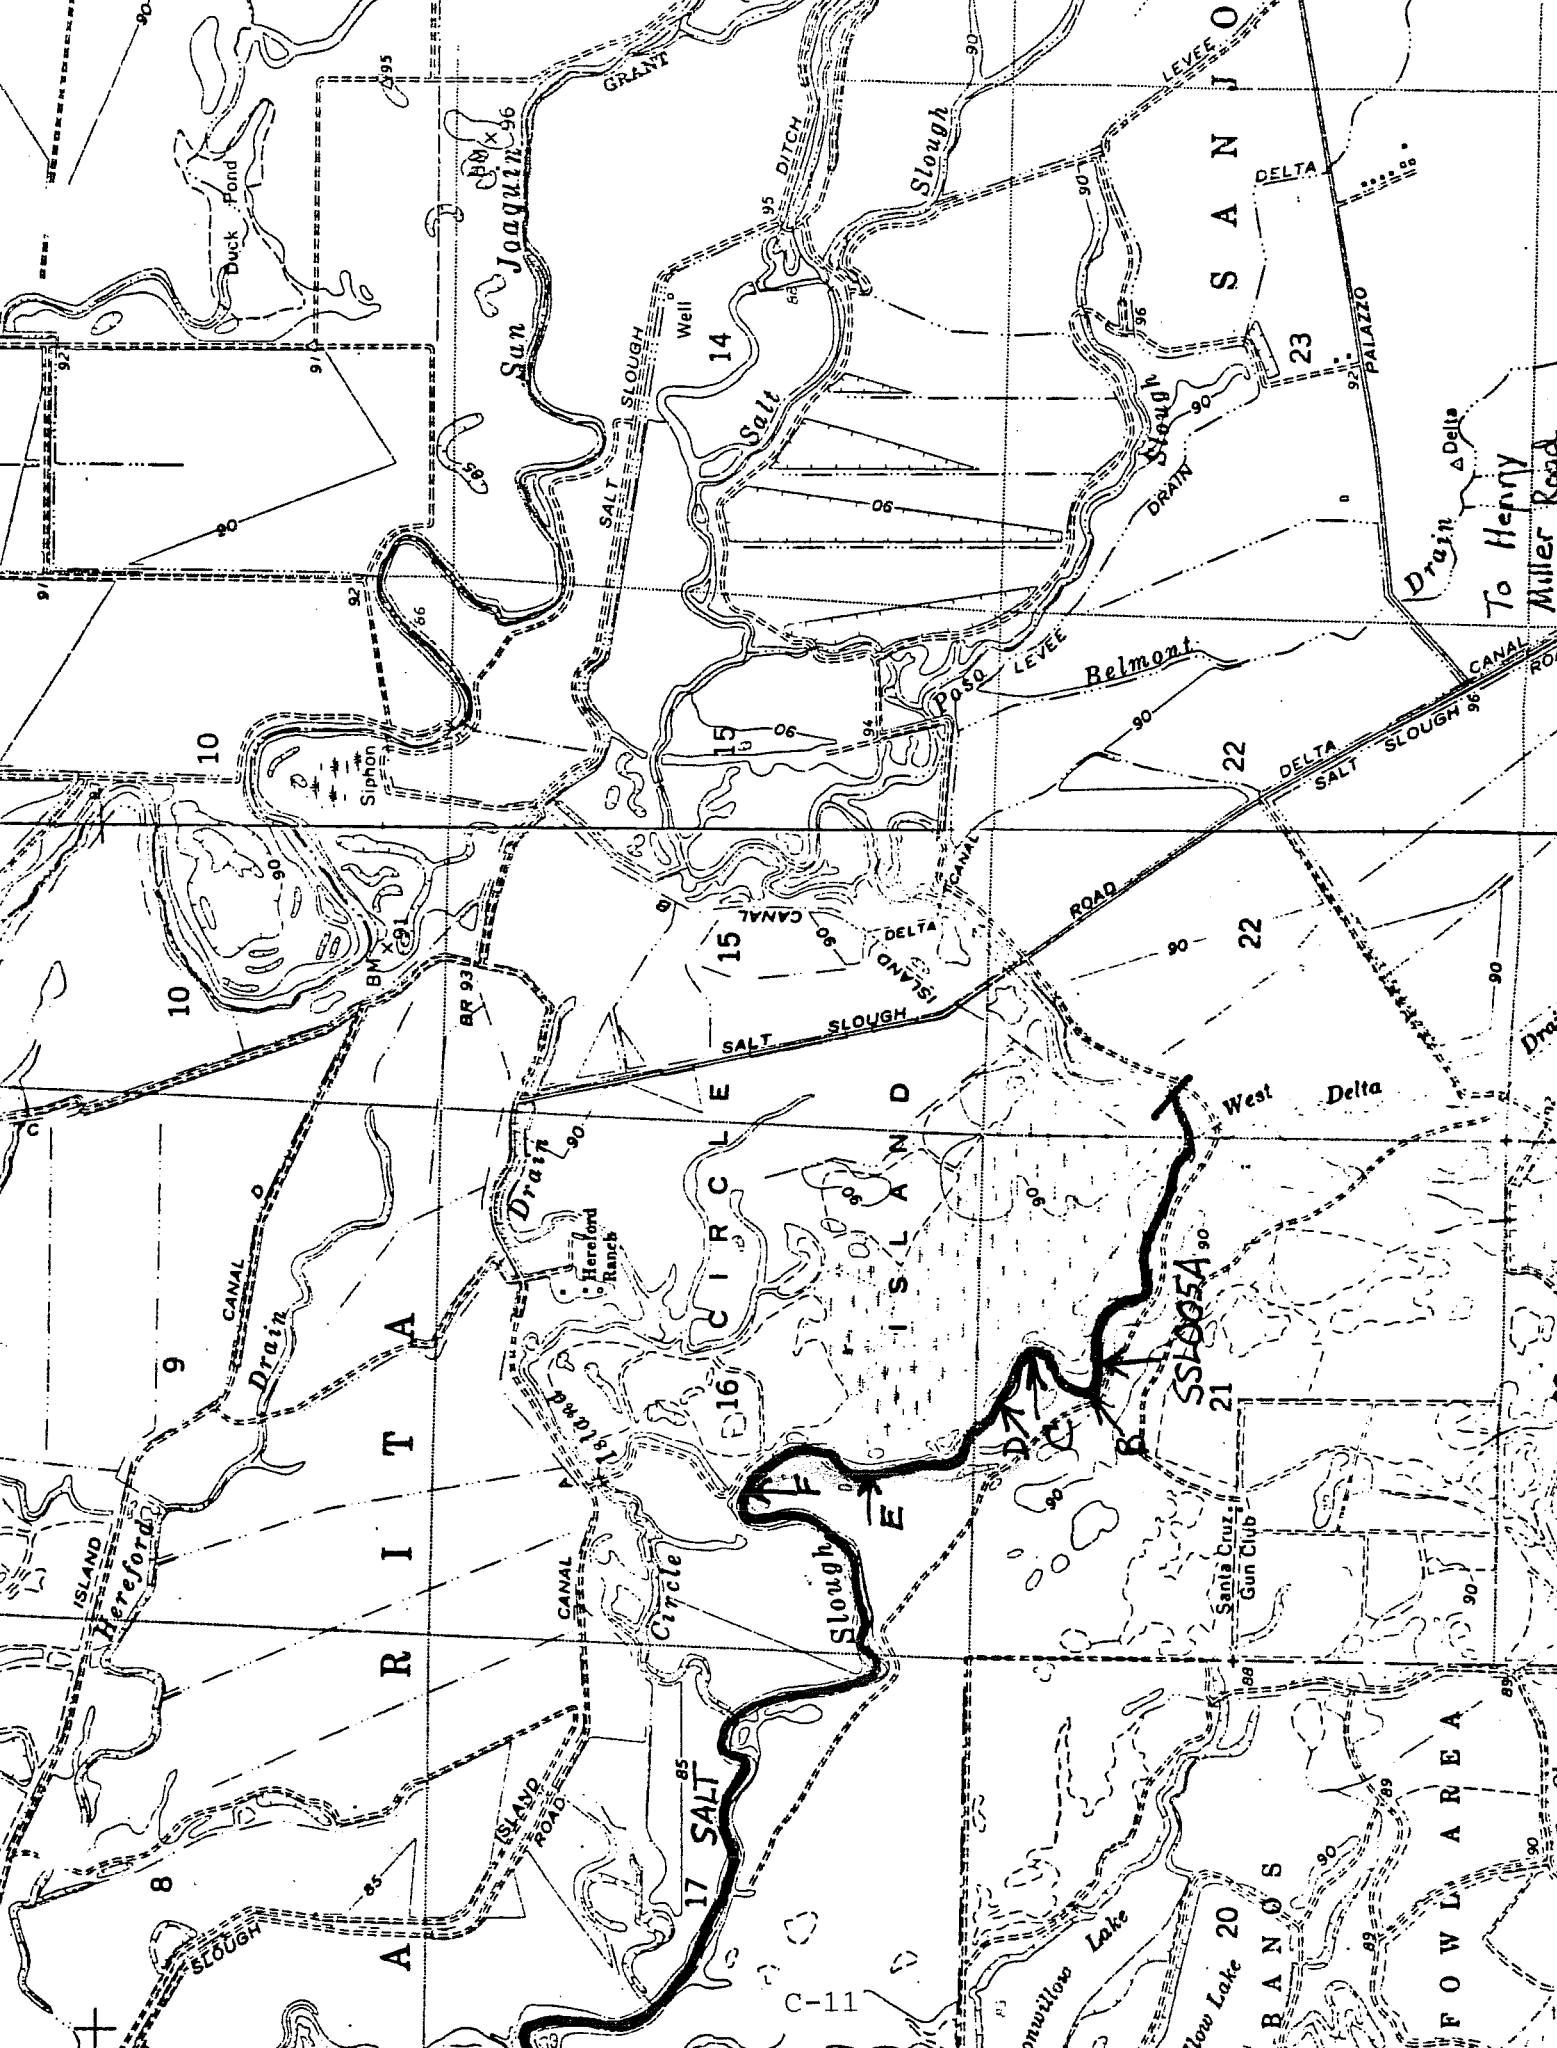
**SITE ID #SSL005A-F**

**Type and source of water being discharged (description):** Each drain is a field drain draining surface water from an area just south of Salt Slough.

<u>Site #</u>	<u>Slough Mileage</u>	<u>Site Description</u>
SSL005A	0.46S	Small corrugated pipe entering Slough.
SSL005B	0.51W	Corrugated pipe entering Slough 0.05 miles west of SSL005A.
SSL005C	0.66W	Small pipe undercrossing levee road 0.2 miles northwest of SSL005A.
SSL005D	0.74S	Small corrugated pipe entering the Slough 0.3 miles northwest of SSL005A.
SSL005E	0.95W	Small pipe undercrossing the levee road 0.5 miles northwest of SSL005A.
SSL005F	1.25S	Small corrugated pipe undercrossing the levee road 0.8 miles northwest of SSL005A.

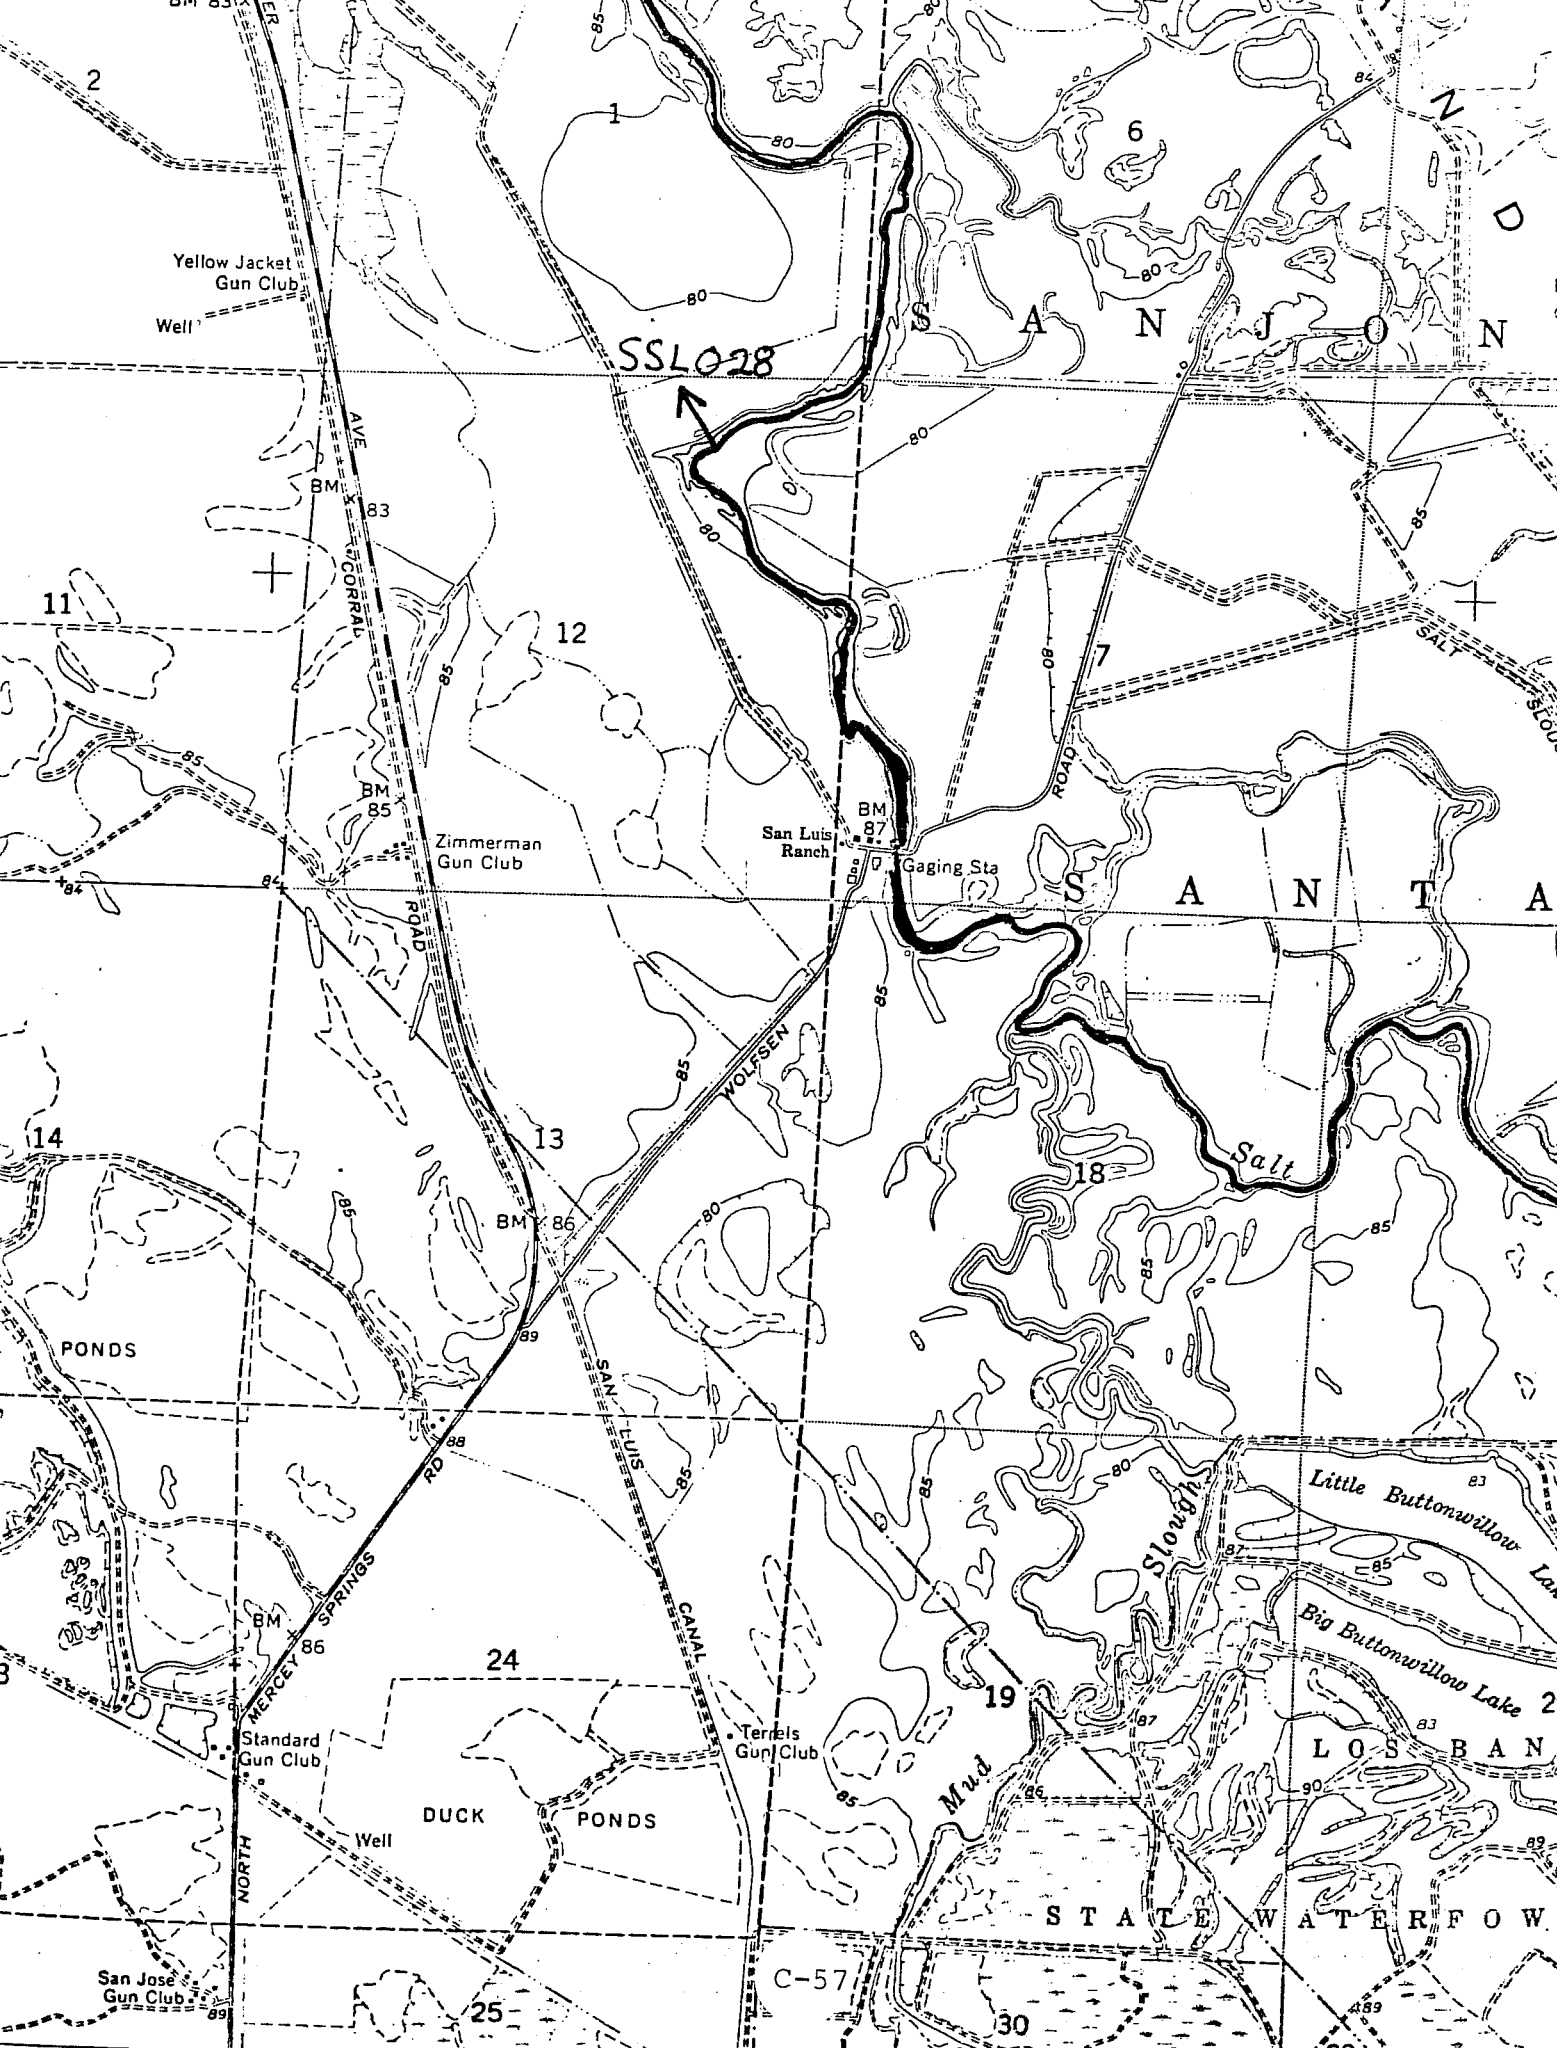
**SITE ID #SSL028**

**Site description, location, and access:** From Los Banos take Mercy Springs Road north for approximately 6.5 miles to Wolfsen Road. Proceed northeast on Wolfsen Road for 0.9 miles to the San Luis Ranch. At this point the road crosses Salt Slough. Proceed across the bridge and turn north onto the east bank of the Slough. From here, follow the east bank of the Slough north for approximately 1.1 miles to where a pump with a yellow motor lifts water from the west bank of the Slough. This is the diversion site.

**Type of diversion and use of the water:** Water is diverted at this point by a lift pump and is used to irrigate pastureland to the west of Salt Slough. This is one of four diversions diverting a total of 47.0 cfs.

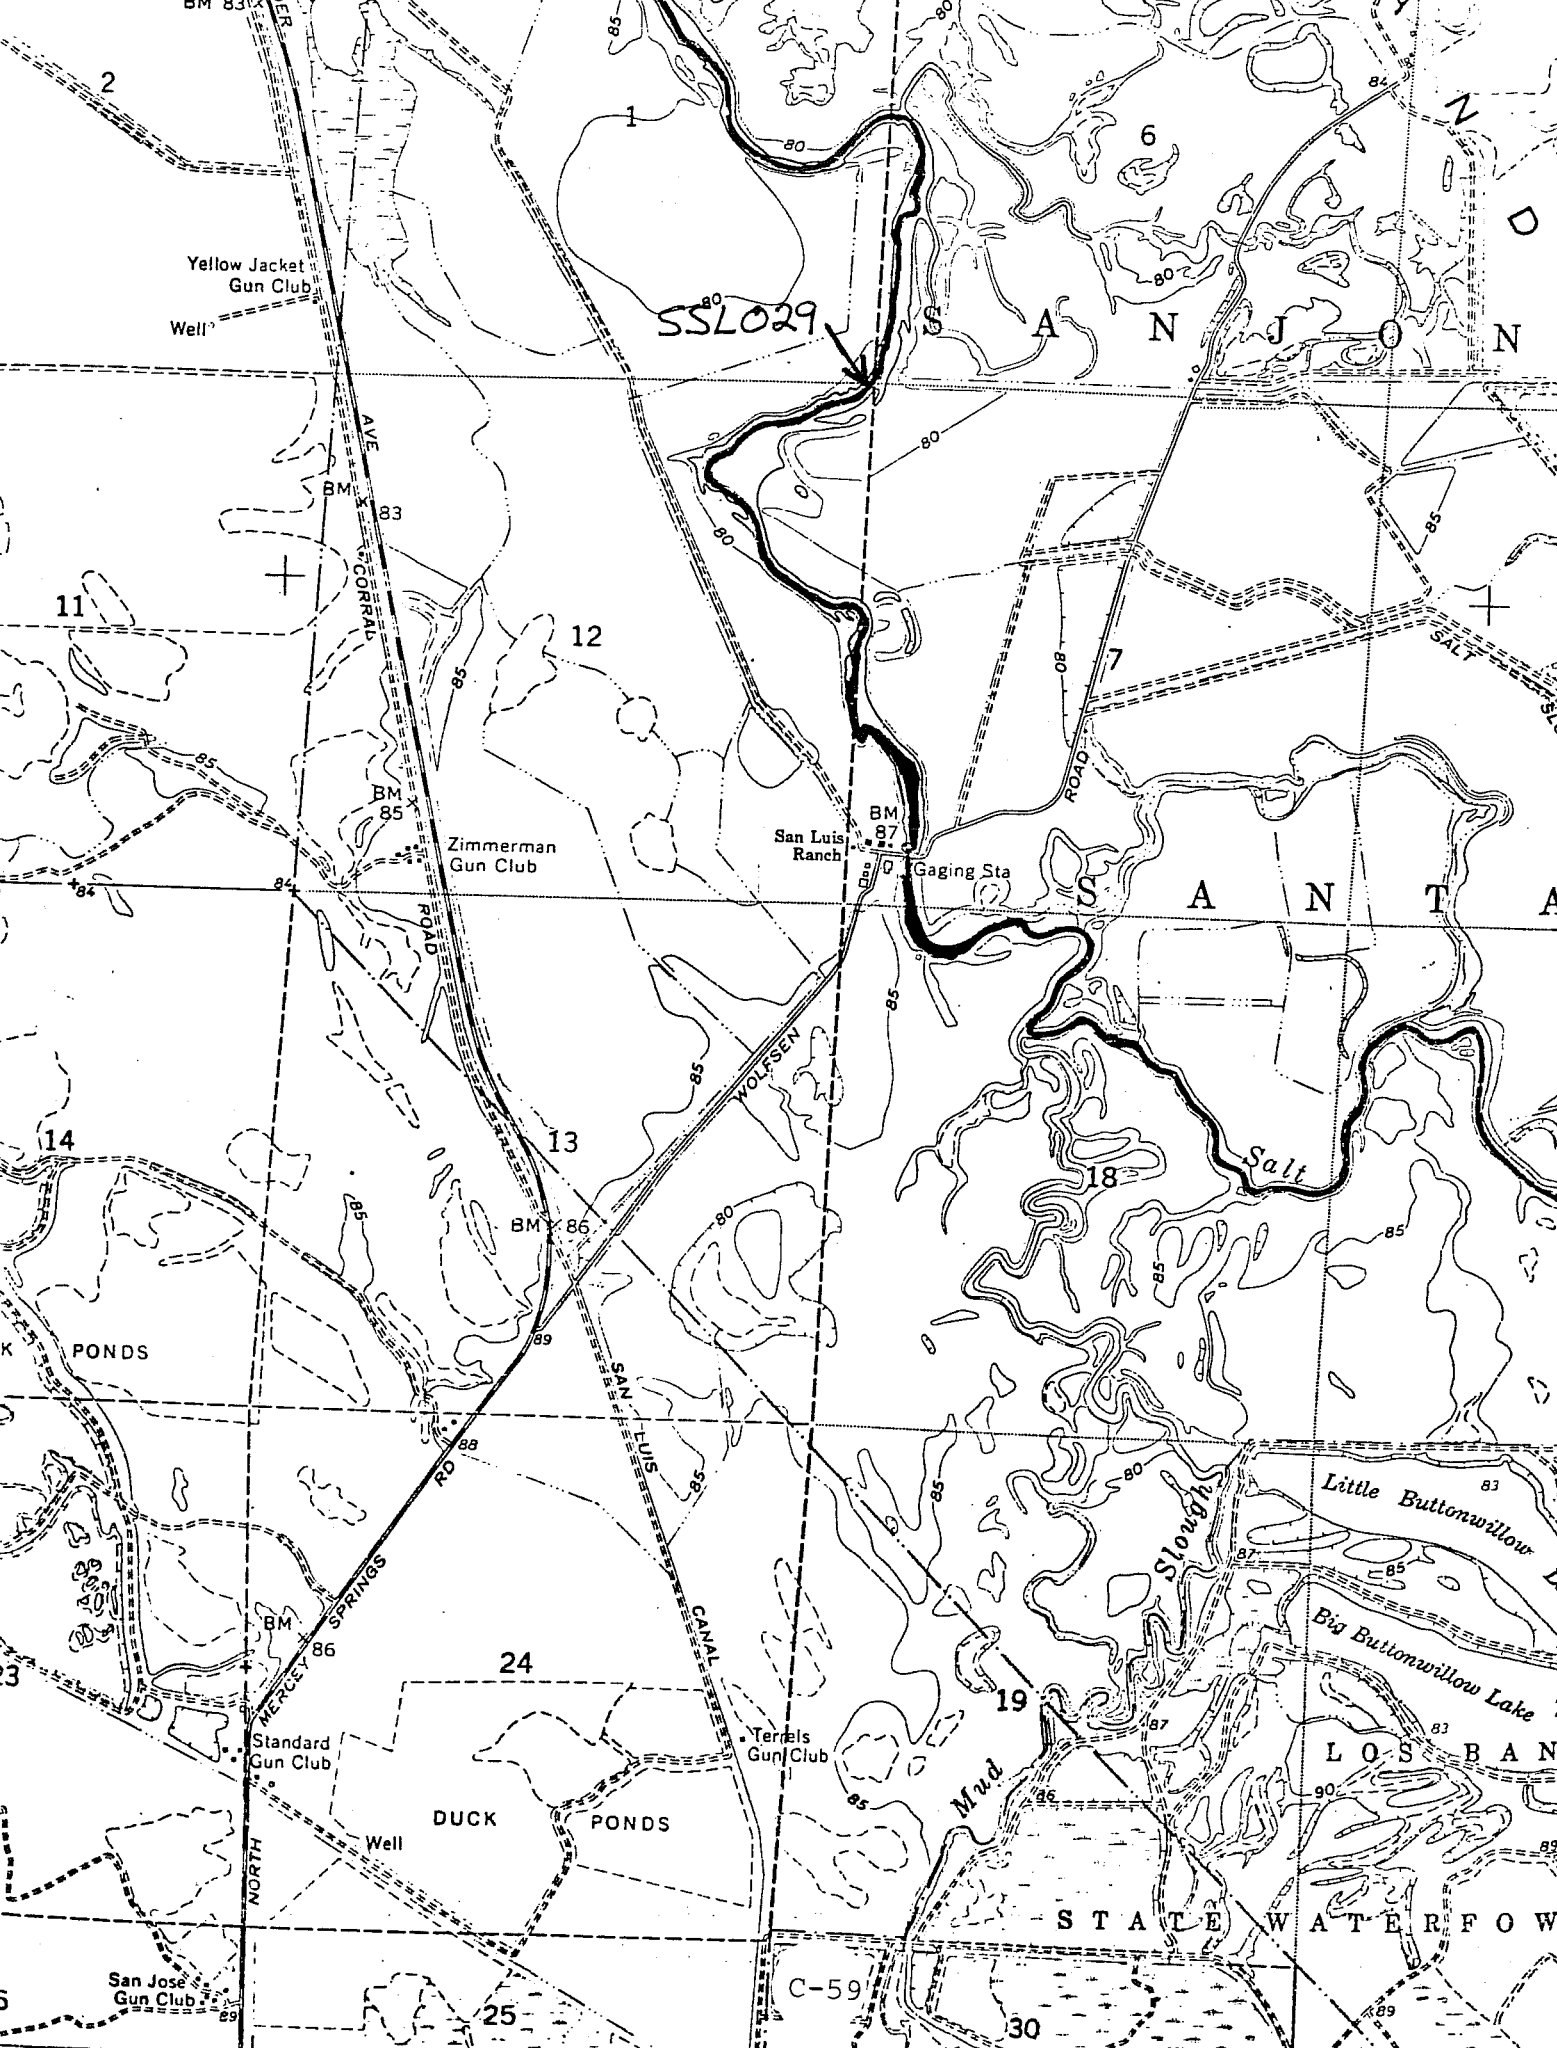
SITE ID #SSL029

**Site description, location, and access:** From Los Banos take Mercy Springs Road north for approximately 6.5 miles to Wolfsen Road. Proceed northeast on Wolfsen Road for 0.9 miles to the Luis Ranch. At this point, the road crosses Salt Slough. From here, walk along the west bank of the Slough for approximately 1.5 miles to where a small channel flows from an irrigation ditch to the Slough. This is the discharge site.

**Type and source of water being discharged (description):** Water discharged at this point is irrigation spill from a ditch used to irrigate pastureland just west of Salt Slough.
